# Confidential Inspection Report

LOCATED AT:  
8 Sally Road  
Chesterfield, New Jersey 07000

INSPECTED ON:  
Saturday, December 15, 2018

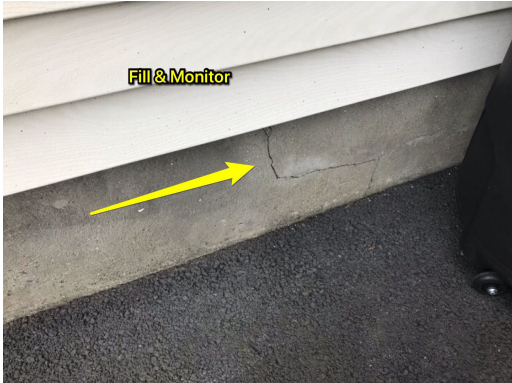
**FYI** There are small and/or moderate cracks visible. We observed no related conditions suggesting the need for immediate repairs. We recommend these cracks be filled and monitored. If ongoing movement is observed, further review would then be recommended.

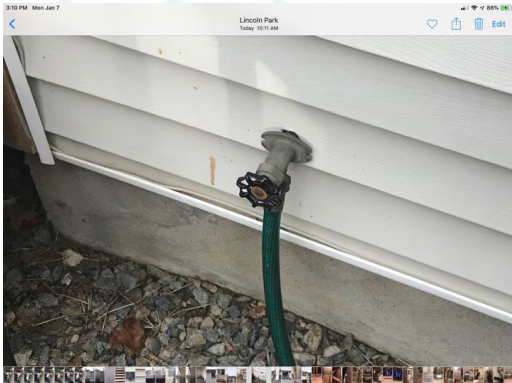
**FYI** Water pipes and/or hose bibs that are vulnerable to freezing were noted on the exterior of the house. During freezing weather, water pipes in unprotected and unheated spaces must be protected from extreme cold to prevent costly damage.

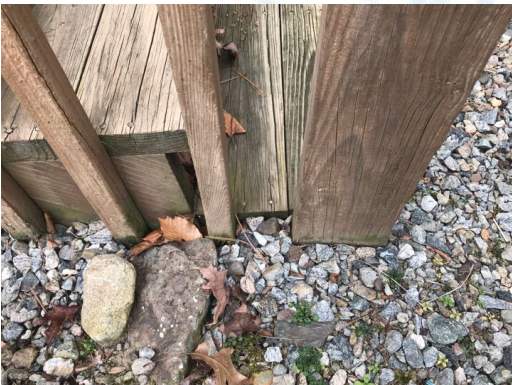
**FYI** There is earth-wood contact at support columns. This is creating a condition conducive to wood-destroying pest or organism activity. We recommend that all columns be anchored in/on cement and that all wood support structures be kept at least 6" away from any soil.

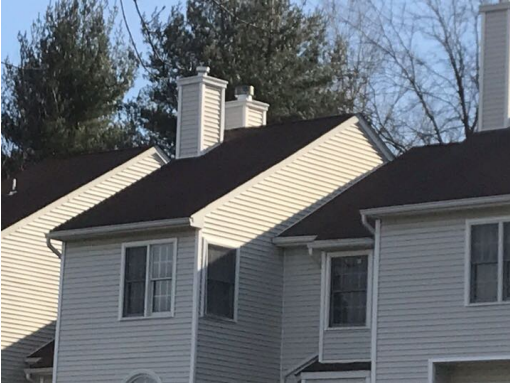
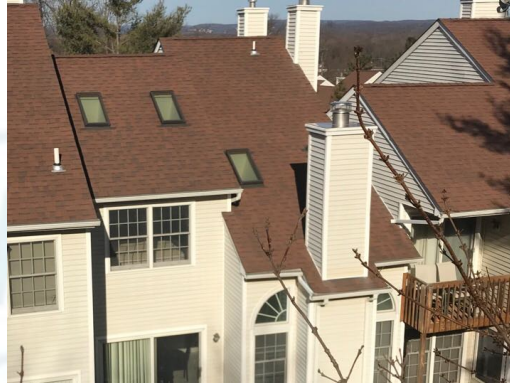
**LIM** The roof is a common area and although looked at with binoculars from a variety of locations, and appeared to be in good shape, it was not fully inspected. Consultation with the Homeowner's Association regarding reserves and maintenance schedules is suggested.

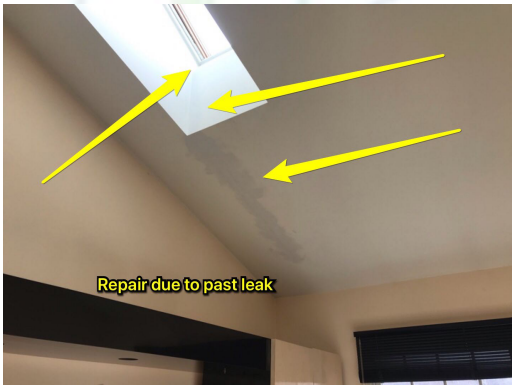
**ATTN** The skylights appear to be properly installed and, with the exception of the one in the master bedroom, do not show evidence of past leakage. **NOTE MAINTENANCE ITEM:** Skylights require ongoing monitoring and maintenance. We recommend checking annually and recaulking/reglazing/resealing when required.

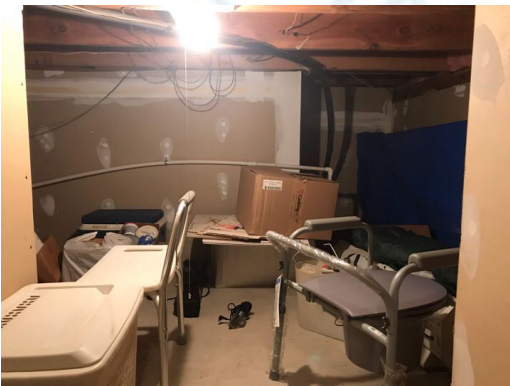
**LIM** The crawl space/storage area is accessible from behind the water heater. There were personal items that prevented a complete inspection, but the areas accessible appeared to be in good shape.

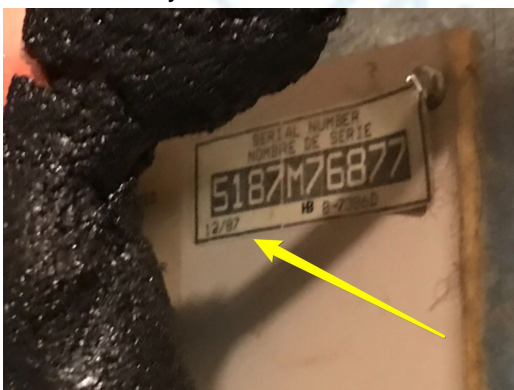
The heating system is dated to 1987 by its label. At 30+ years old, is near the end of its expected service life. Although it responded to normal operating controls, the need for replacement should be expected within the next few years.

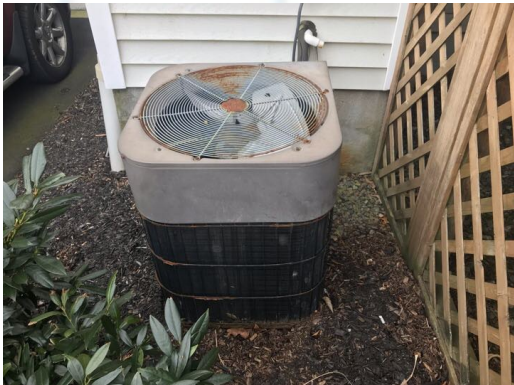
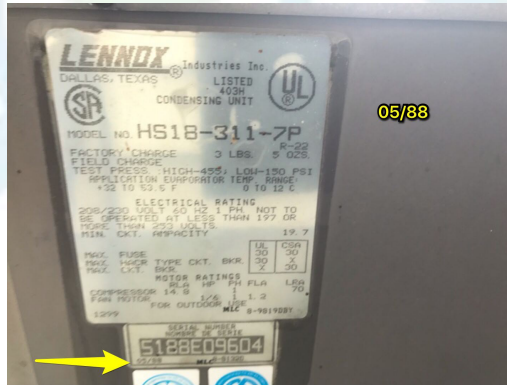
**FYI** **ATTN** The air conditioning is near the end of its expected service life at an age of 30+ years. Although it could not be tested, the need for replacement should be expected within the next few years.

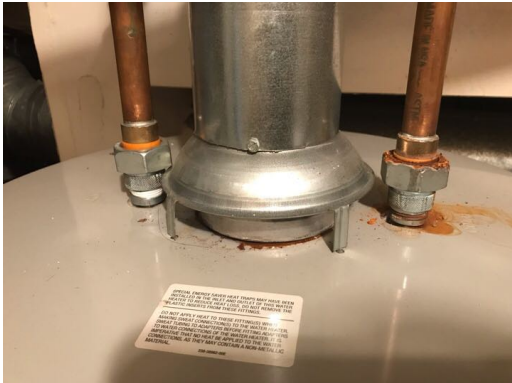
**FYI** The water connections are corroded and leakage may become apparent over time. These connections should be monitored for leakage and repaired or replaced if necessary. There is also corrosion visible around the exhaust collar. This should be monitored for leaks over time as well.

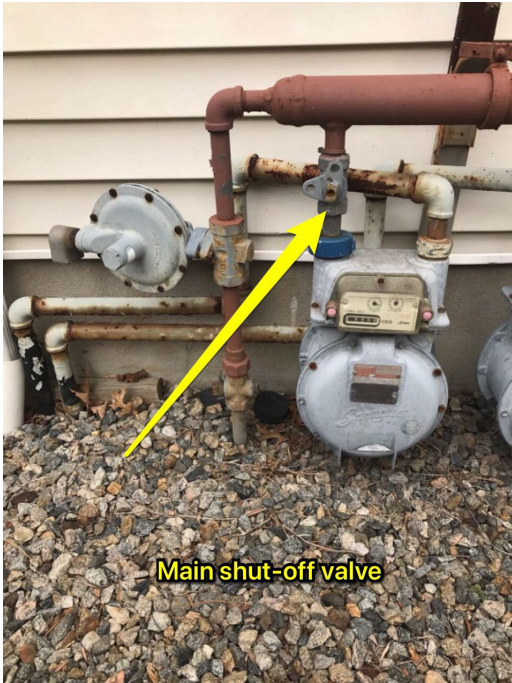
**FYI** There is no meter wrench attached to the gas meter. We recommend leaving a wrench chained to the meter to provide means for an emergency shutoff.

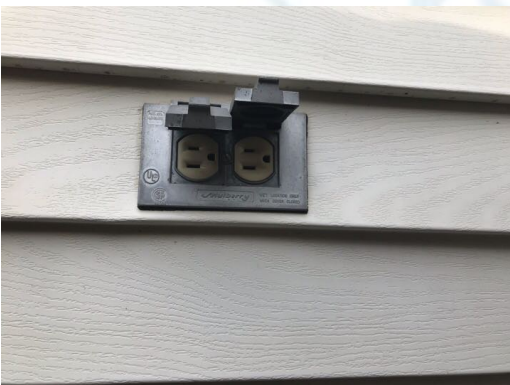
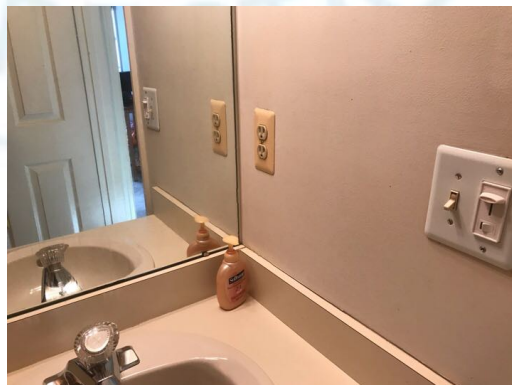
**ATTN** Incomplete GFCI protection is present. We recommend upgrading by installing ground fault receptacles in all locations required by present standards. These include receptacles near sink basins, in bathrooms, garages, crawl spaces, and the exterior. Note: There are no GFICs on at the rear exterior, and in the bathrooms.

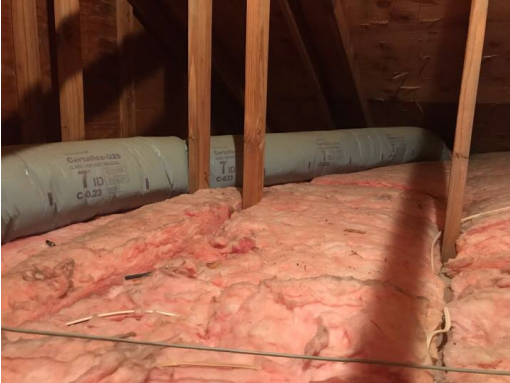
**LIM** Insulation conceals portions of the attic, limiting access and preventing complete inspection. It is inadvisable to walk in attics where this situation is present. No reportable conditions were observed in the visible areas however.

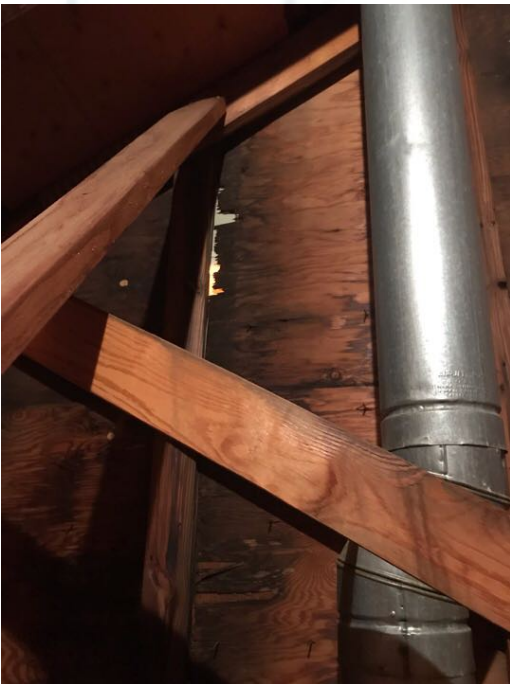
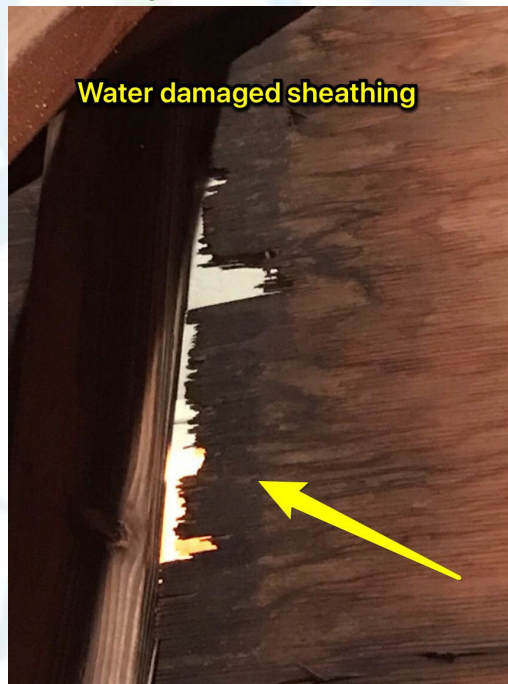
**URG** There is evidence of past leakage and, in our opinion, leaks could still exist. We recommend water testing and/or further investigation by a licensed roofing contractor.

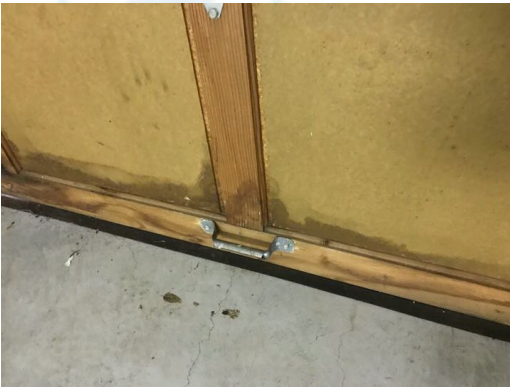
The garage door was operated and appears to be properly installed and in serviceable condition. Some deterioration from moisture is present, but is not an impediment to function at present.

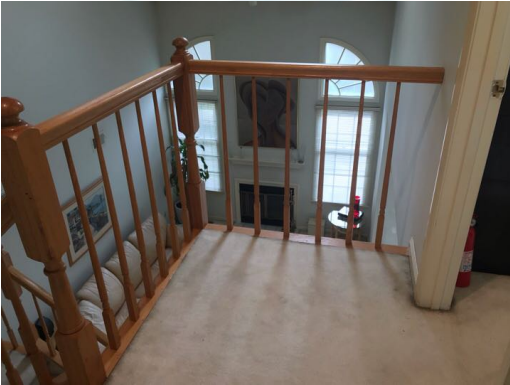
**FYI** The stair railing baluster spacing is nonconforming by present building standards. As an upgrade, the baluster spacing could be brought into conformance for maximum safety.

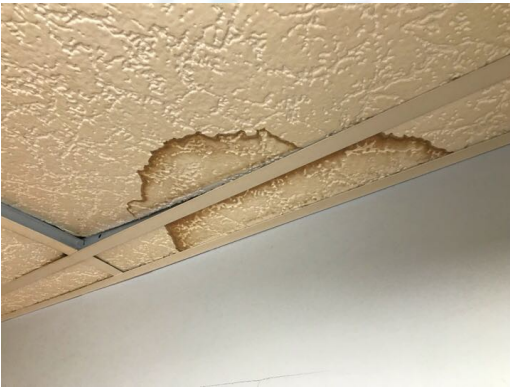
**FYI** The finished surfaces, hardware and door of the basement office were found to be generally in good condition at the time of our inspection. However, this area is in need of routine maintenance as noted above or in other sections of this report. There is evidence of a previous leak as evidenced by the stain on the dropped ceiling in the room. Further investigation is recommended.
