# Confidential Inspection Report

LOCATED AT:  
8 Sally Road  
Chesterfield, New Jersey 07000

INSPECTED ON:  
Saturday, December 15, 2018

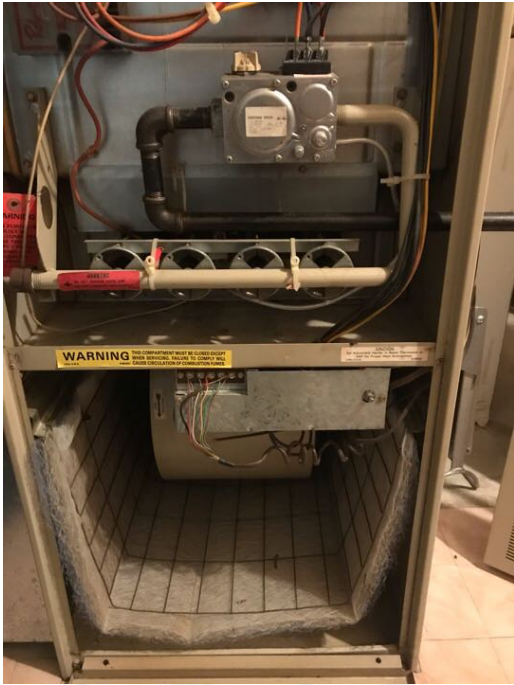
## AIR FILTERS

The air filter for the heating unit is a disposable media 'hammock' type filter.

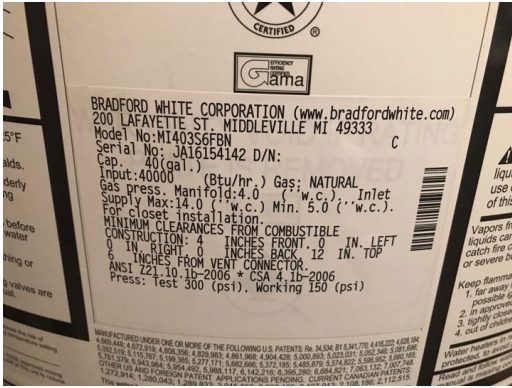
Technical Information: See data plate photo attached.

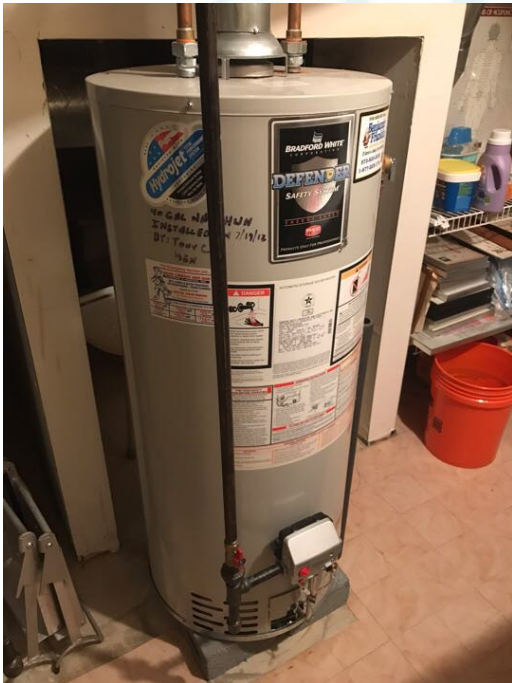
Unit type: Free standing tank

Output: adequate for a home this size.

Age: Estimated to be approximately 6 to 7 years old, dated by the serial number. Water heaters can sometimes last well beyond the warranty period stated. However, the life expectancy varies greatly depending upon local water chemistry, system use, operating temperatures, and maintenance provided. Typically hot water heaters of this type have a life expectancy of 8-12 years but can last much longer. NOTE: Monitor for any leaks and replace when leaks occur.

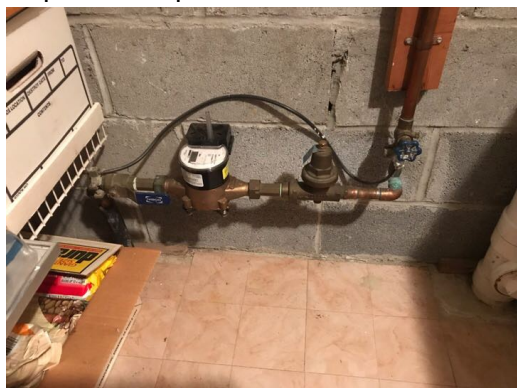
## WATER SHUTOFF COMMENTS

The main shut-off valve was located but testing the operation of this valve is not within the scope of our inspection. Operation of the valve from time to time will keep it functional and maximize its useful life.

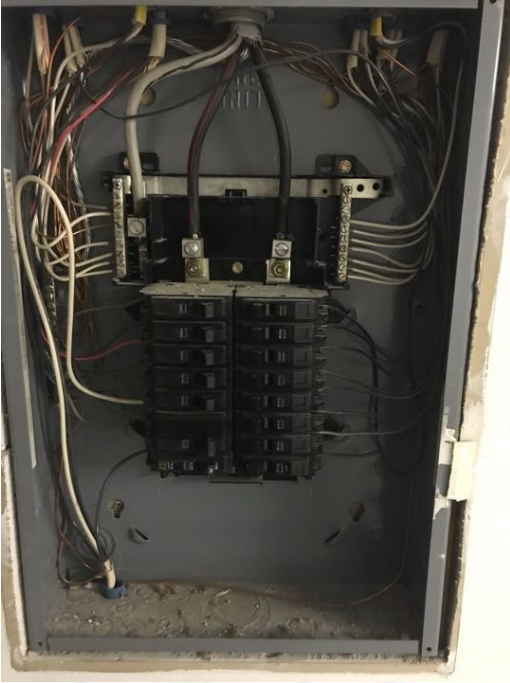
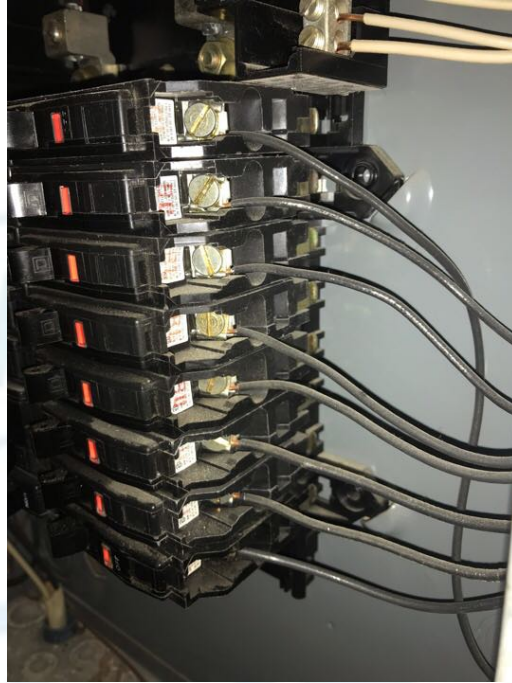
## CB MAIN PANEL

The main service panel is in good condition with circuitry installed and fused correctly.

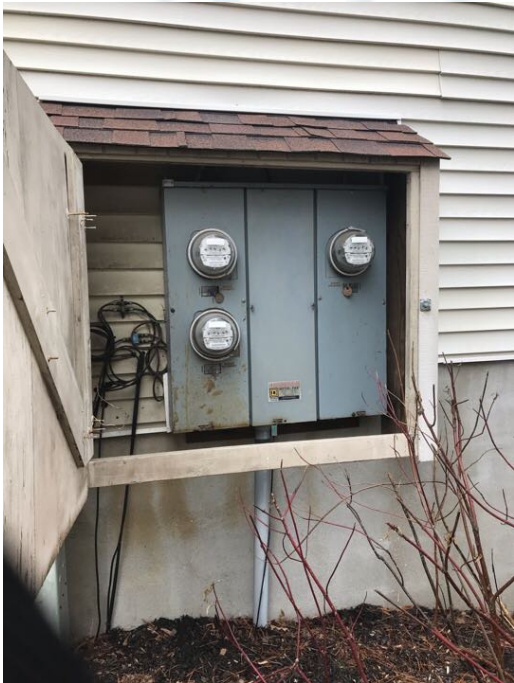
### METER

The meter appears to be installed correctly and was operating and in serviceable condition. It is located on the side end of the townhouse row

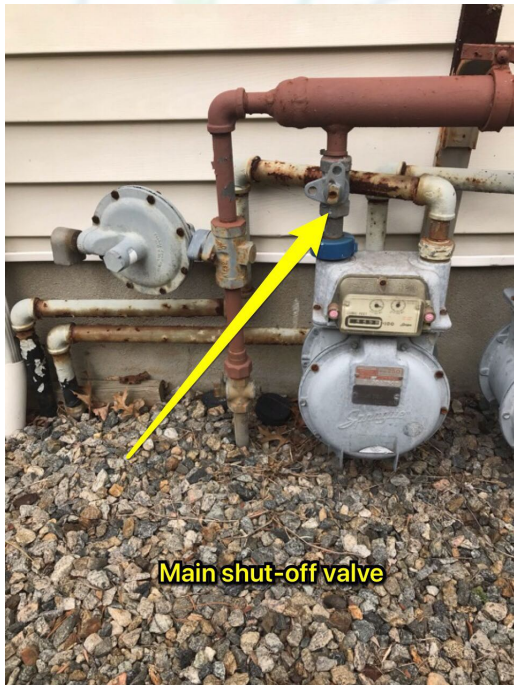
The gas meter is outside at the rear of the building. The main gas supply shutoff valve is located just above the meter. This valve should be turned 90 degrees to the left in order to shut off the gas.
